INSPECTION REPORT

Report No. Props/2019-20/016

[REDACTED] Alpine Tower, Kandivali East,
Mumbai – 400101

Inspection Date

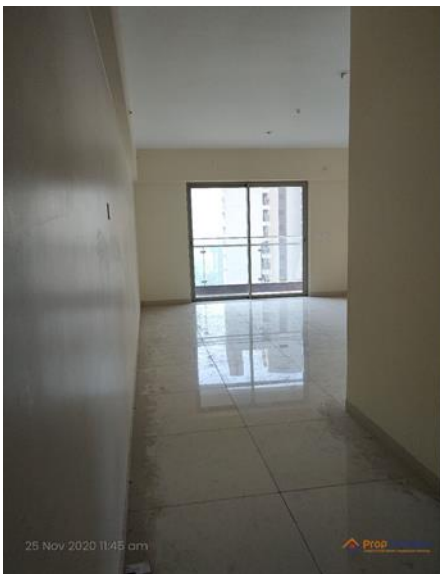
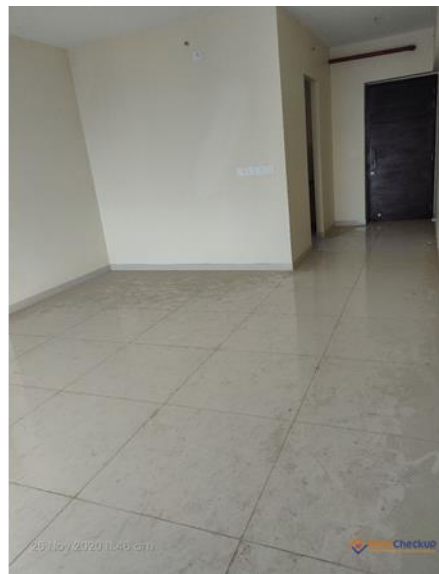
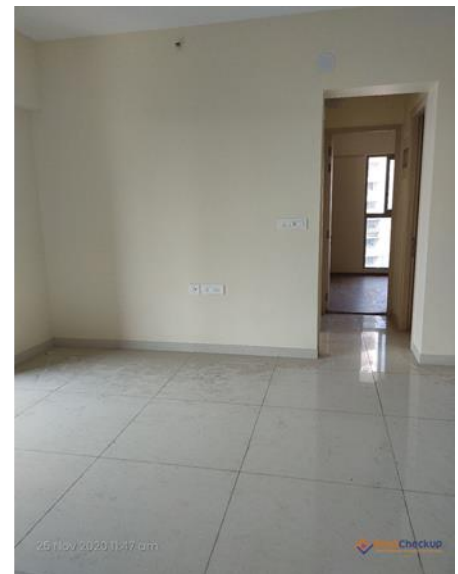
Photos – Living Room

Items	Condition Rating	Impact	Remark
Doors	Repair	Moderate	frame lock plate inside cover damage, improper polish work, door lock plate screw rusted and frame damage
Ceiling	Acceptable	NA	NA
Floors	Acceptable	Moderate	gap between the flooring tile not filled properly and uneven tile work
Lights	Not Available	NA	NA
Switches	Repair	Moderate	door bell switchboard not fixed yet, cleaning required
Painting	Repair	Moderate	hairline crack on wall
Walls	Repair	Moderate	hairline crack near the door wall
Windows	Repair	Moderate	operational issue in lock
Fan	Not Available	NA	NA
A/C	Not Available	NA	NA

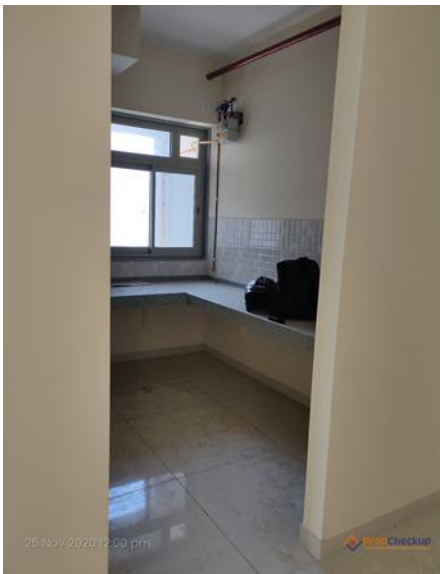
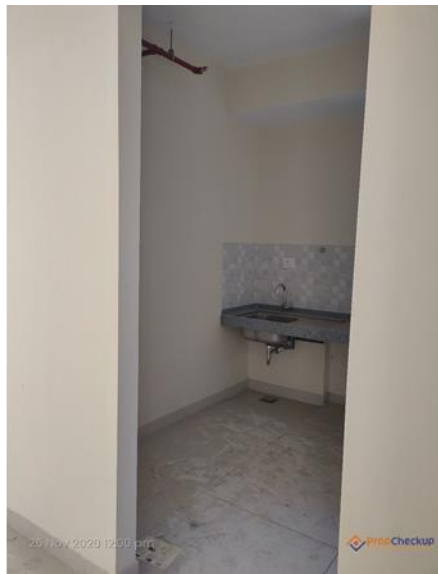
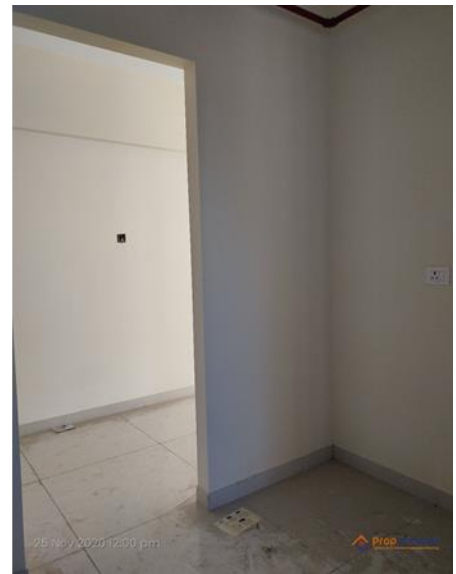
Photos – Kitchen

Items	Condition Rating	Impact	Remark
Dado	Repair	Moderate	dado tile chipped near the two point switchboard and some of the dado tile are hollow
Ceiling	Acceptable	NA	NA
Platform	Acceptable	NA	cleaning required
Floors	Acceptable	NA	cleaning required
Vent	Acceptable	NA	exhaust fan not available, and cleaning required
Lights	Not Available	NA	NA
Switches	Acceptable	NA	NA
Sink Wash	Acceptable	Moderate	rusting on sink outlet and cleaning required
Painting	Repair	Moderate	hairline crack and stain on wall beside the window
Walls	Repair	Moderate	hairline crack and chipping over the wall and angle cock not fixed properly
Windows	Acceptable	NA	NA
Furniture	Not Available	NA	NA

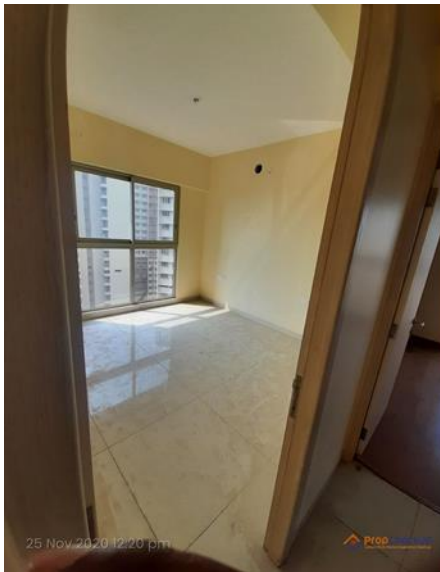
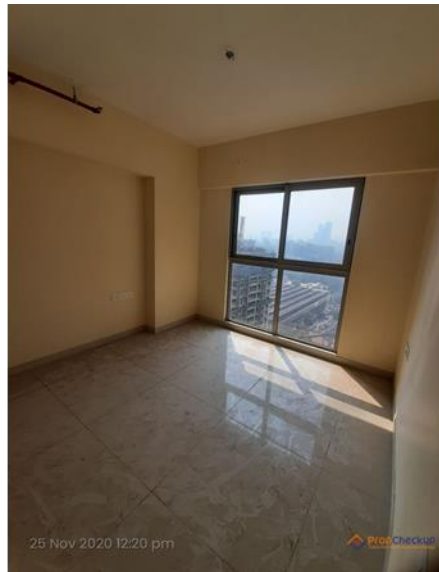
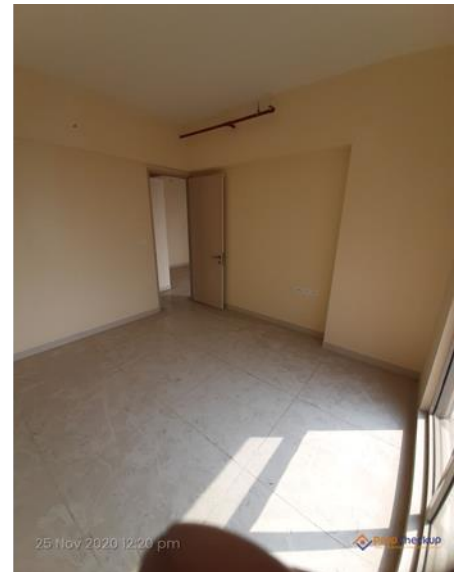
Photos – Bed Room 1

Items	Condition Rating	Impact	Remark
Doors	Acceptable	NA	NA
Doors	Acceptable	NA	NA
Floors	Acceptable	Moderate	gap not properly filled
Lights	Not Available	NA	NA
Switches	Acceptable	NA	cleaning required
Painting	Acceptable	NA	NA
Walls	Acceptable	NA	NA
Windows	Repair	High	Functionality issue in window lock
A/C	Not Available	NA	NA
Fan	Not Available	NA	NA

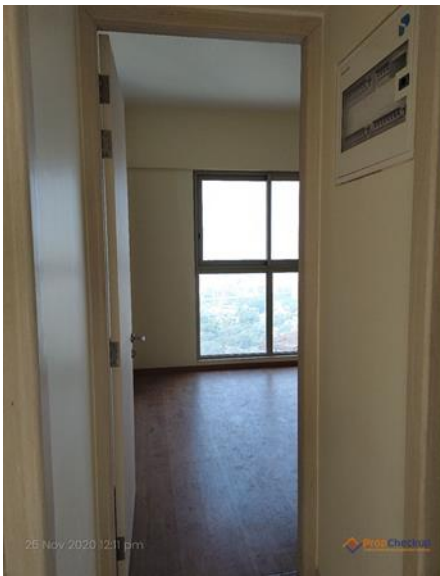
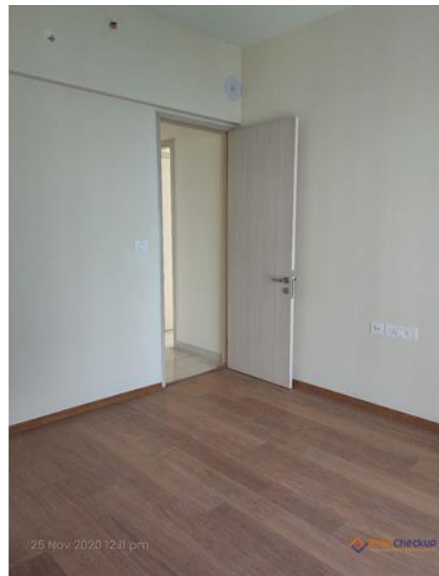
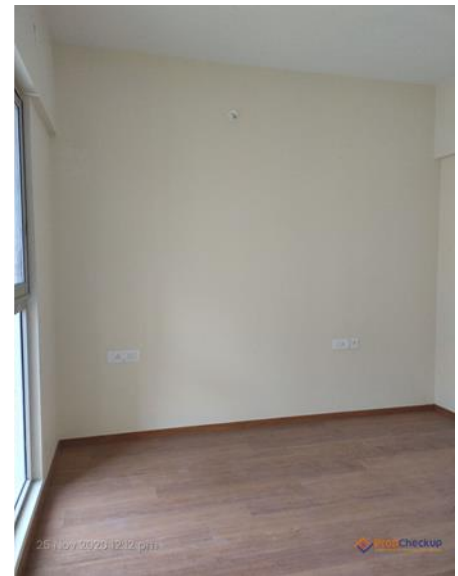
Photos – Bed Room 2

Items	Condition Rating	Impact	Remark
Doors	Repair	Moderate	door frame lock plate not fixed properly, door chipped over the hinges and door not closing because the veranda plate is damage
Floors	Repair	High	veranda plate damage and some of the gap between skirting are not filled
Lights	Not Available	NA	NA
Switches	Acceptable	NA	NA
Painting	Repair	Moderate	hairline crack on wall
Walls	Repair	Moderate	hairline crack on wall
Windows	Repair	High	functionality issue in window locks
A/C	Not Available	NA	NA
Fan	Not Available	NA	NA

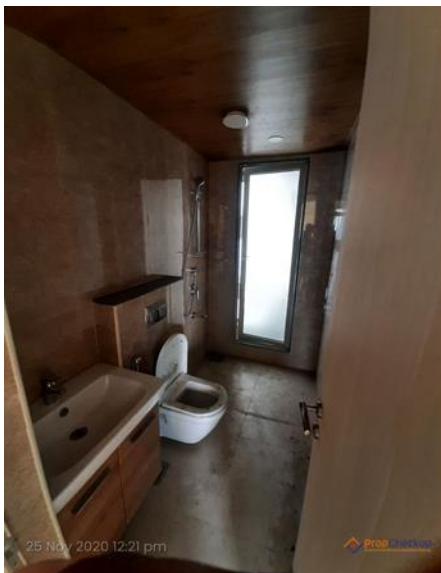
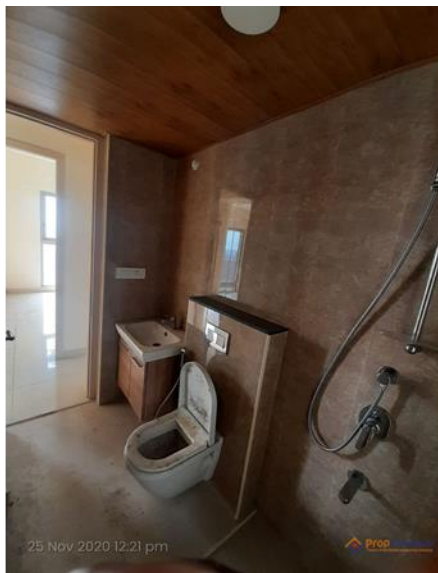
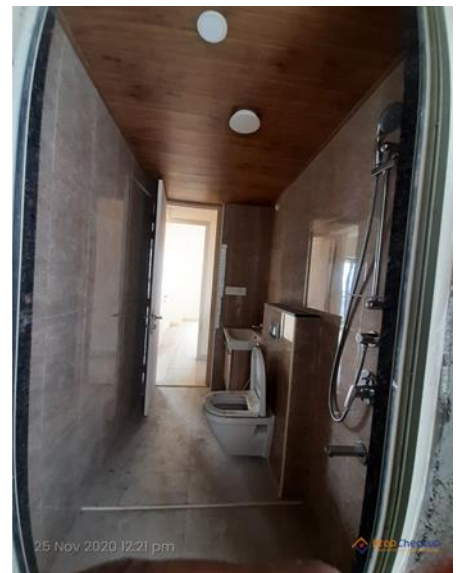
Photos – Bathroom 1

Items	Condition Rating	Impact	Remark
Ceiling	Acceptable	Moderate	Cleaning required
Switch Board	Acceptable	NA	NA
Wash Basin	Repair	High	Basin outlet coupling rusted
Dado	Acceptable	NA	NA
Doors	Repair	High	door sunmica damaged
Floors	Acceptable	NA	NA
Fixture	Repair	High	Whole fixture rusted
WC	Acceptable	Moderate	cleaning required
Flush	Repair	High	flush cover plate rusted
Shower	Repair	Moderate	damaged coating
Walls	Acceptable	NA	NA
Windows	Repair	High	improper alignment
Lights	Acceptable	NA	Electric supply not available
Mirror	Not Available	NA	NA
Exhaust	Not Available	NA	NA
Geyser	Not Available	NA	NA
Outlet	Repair	High	outlet cover rusted

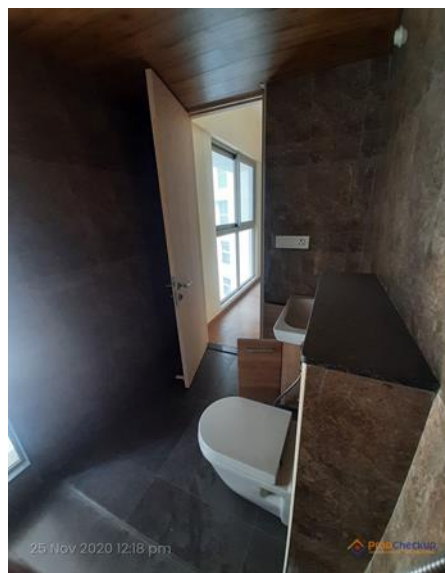
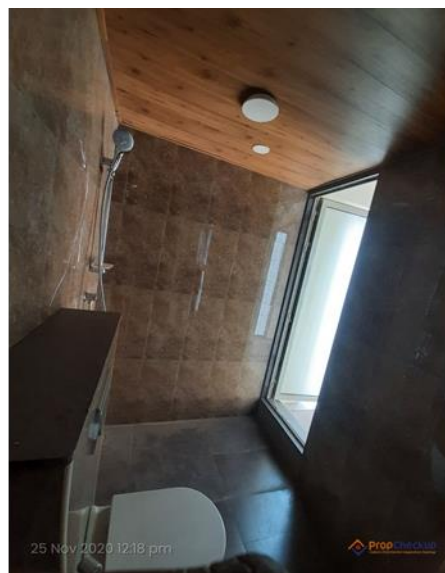
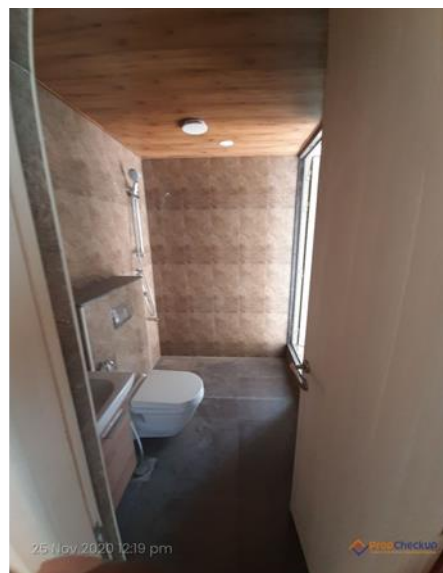
Photos – Bathroom 2

Items	Condition Rating	Impact	Remark
Ceiling	Repair	High	Noticed damages
Dado	Acceptable	NA	NA
Switch Board	Acceptable	NA	electric supply not available
Wash Basin	Acceptable	NA	NA
Doors	Repair	Moderate	door damage at it's edge beside the lock
Floors	Acceptable	NA	NA
WC	Acceptable	NA	cleaning required
Flush	Repair	High	cover plate rusted
Shower	Acceptable	NA	NA
Walls	Acceptable	NA	NA
Windows	Repair	High	Functionality issue in window lock
Lights	Acceptable	NA	Electric supply not available
Mirror	Not Available	NA	NA
Exhaust	Not Available	NA	NA
Geyser	Not Available	NA	NA
Outlet	Repair	High	outlet cover rusted
Fixture	Repair	High	Whole fixture coating roasted

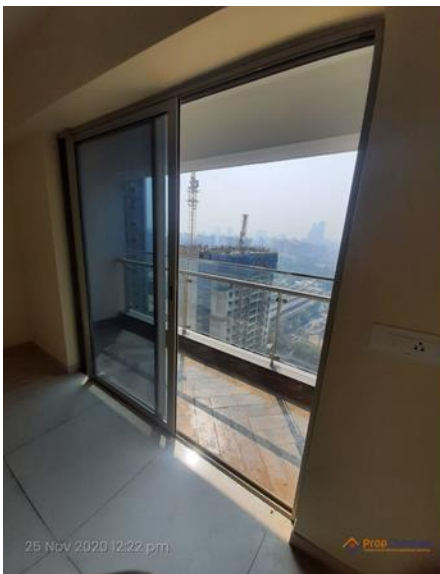
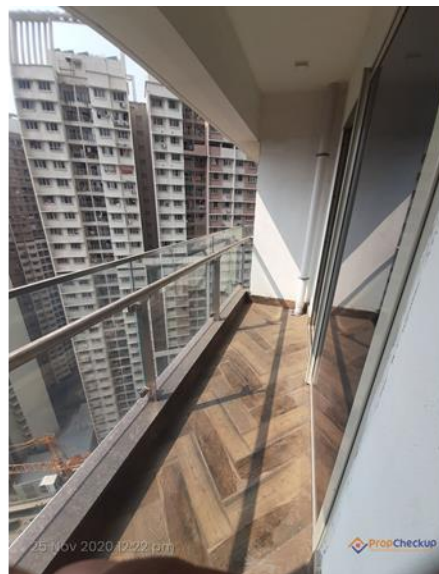
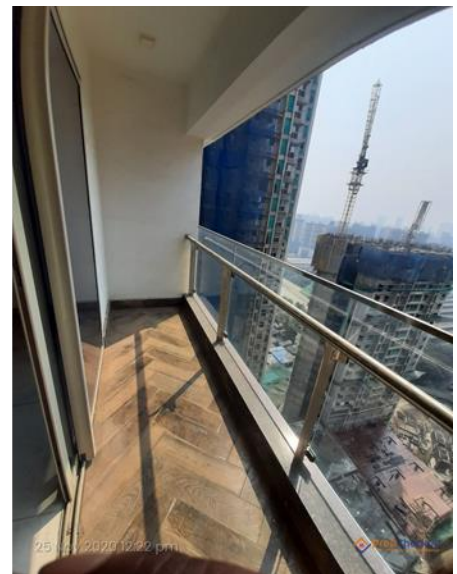
Photos – Balcony

Items	Condition Rating	Impact	Remark
Ceiling	Acceptable	Moderate	cleaning required
Floors	Repair	High	Uneven tiles joint
Walls	Acceptable	NA	NA
Grills	Repair	Moderate	multiple location rusted
Outlet	Repair	Moderate	outlet cover not properly fixed

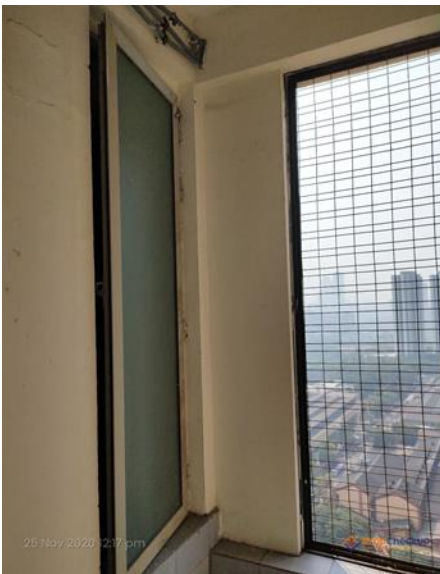
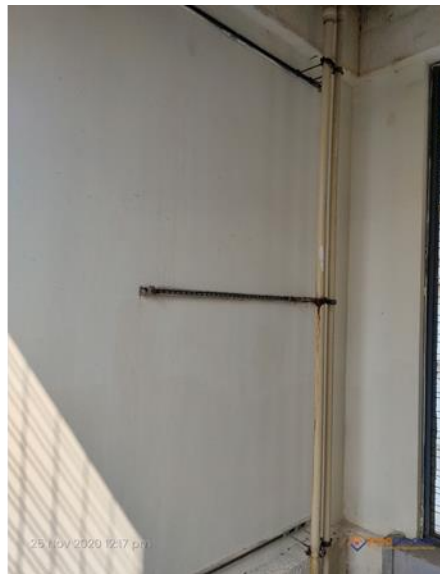
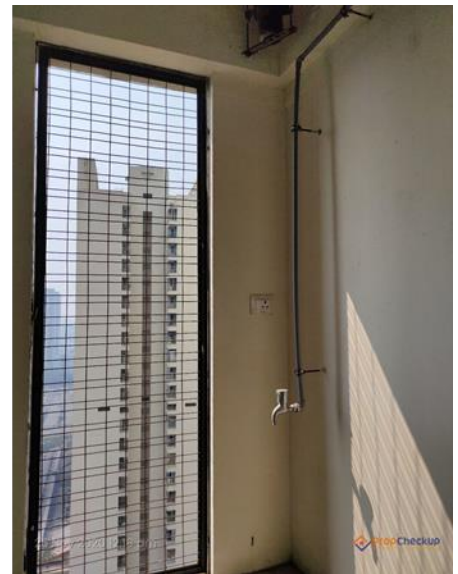
Photos – Utility Area

Items	Condition Rating	Impact	Remark
Ceiling	Acceptable	NA	plumbing outlet inlet pipe is open
Floors	Repair	Moderate	cleaning required and dado damaged
Walls	Repair	Moderate	hairline crack on wall
Grills	Repair	High	both the grills rusted
Outlet	Repair	High	outlet plate rusted
